FINAL  
FOUNDATION  
REPORT

COMPLETION OF EMBANKMENT  
OUTLET WORKS AND SPILLWAY  
COOPER LAKE  
SULPHUR RIVER, TEXAS

CORPS OF ENGINEERS  
FORT WORTH DISTRICT, TEXAS

MAY 1992

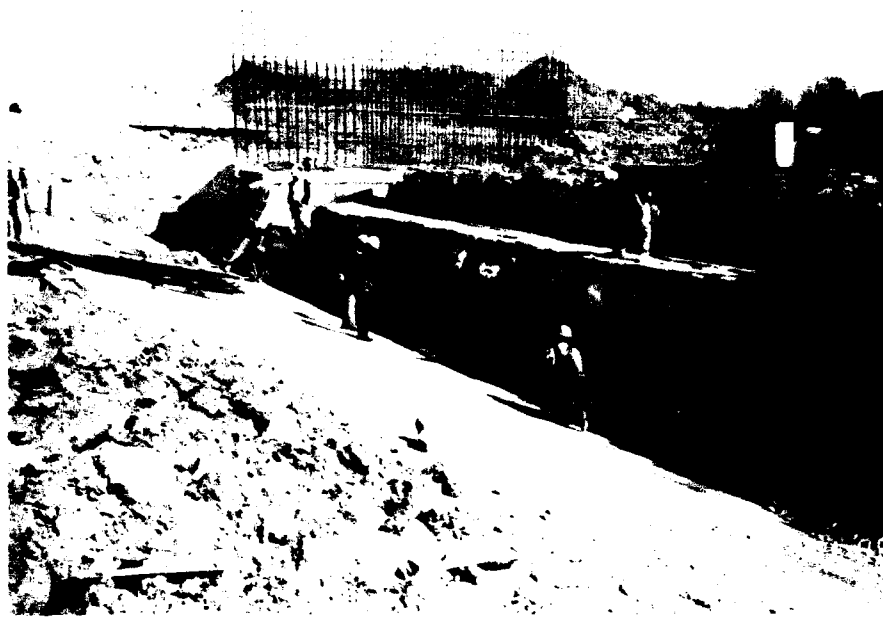
**FIGURE 10.** Looking right and upstream. Spillway weir foundation with right wall footing (R-6) in background. Note limestone in backslope (upstream) overlain by re-compacted clay and underlain by undisturbed fine sand.

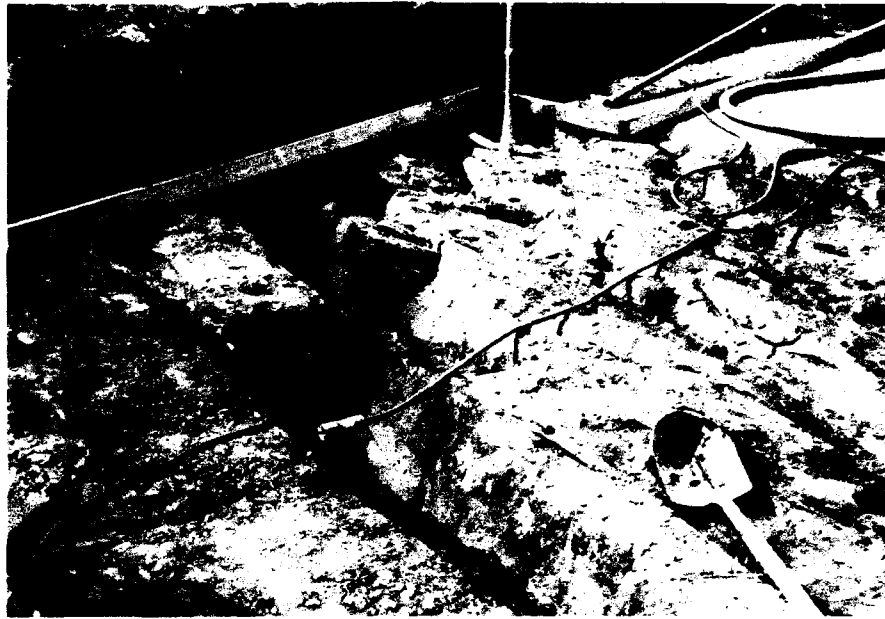
**FIGURE 20.** Upstream portion of spillway wall footing R-15 (end wall footing). This is a close view of fractures shown in figure 19. Fractures are in sets, dipping in opposite directions.
